# Executive Summary

# Engineer's Foundation Evaluation

123 Sample Address, Your City, CO, 12345

On 4/1/2024 a foundation evaluation was performed at the property located at address 123 Sample Address, Your City, CO, 12345, which consists of a 2042 square-foot single family attached structure built in 2005 with a block / pier & beam foundation.

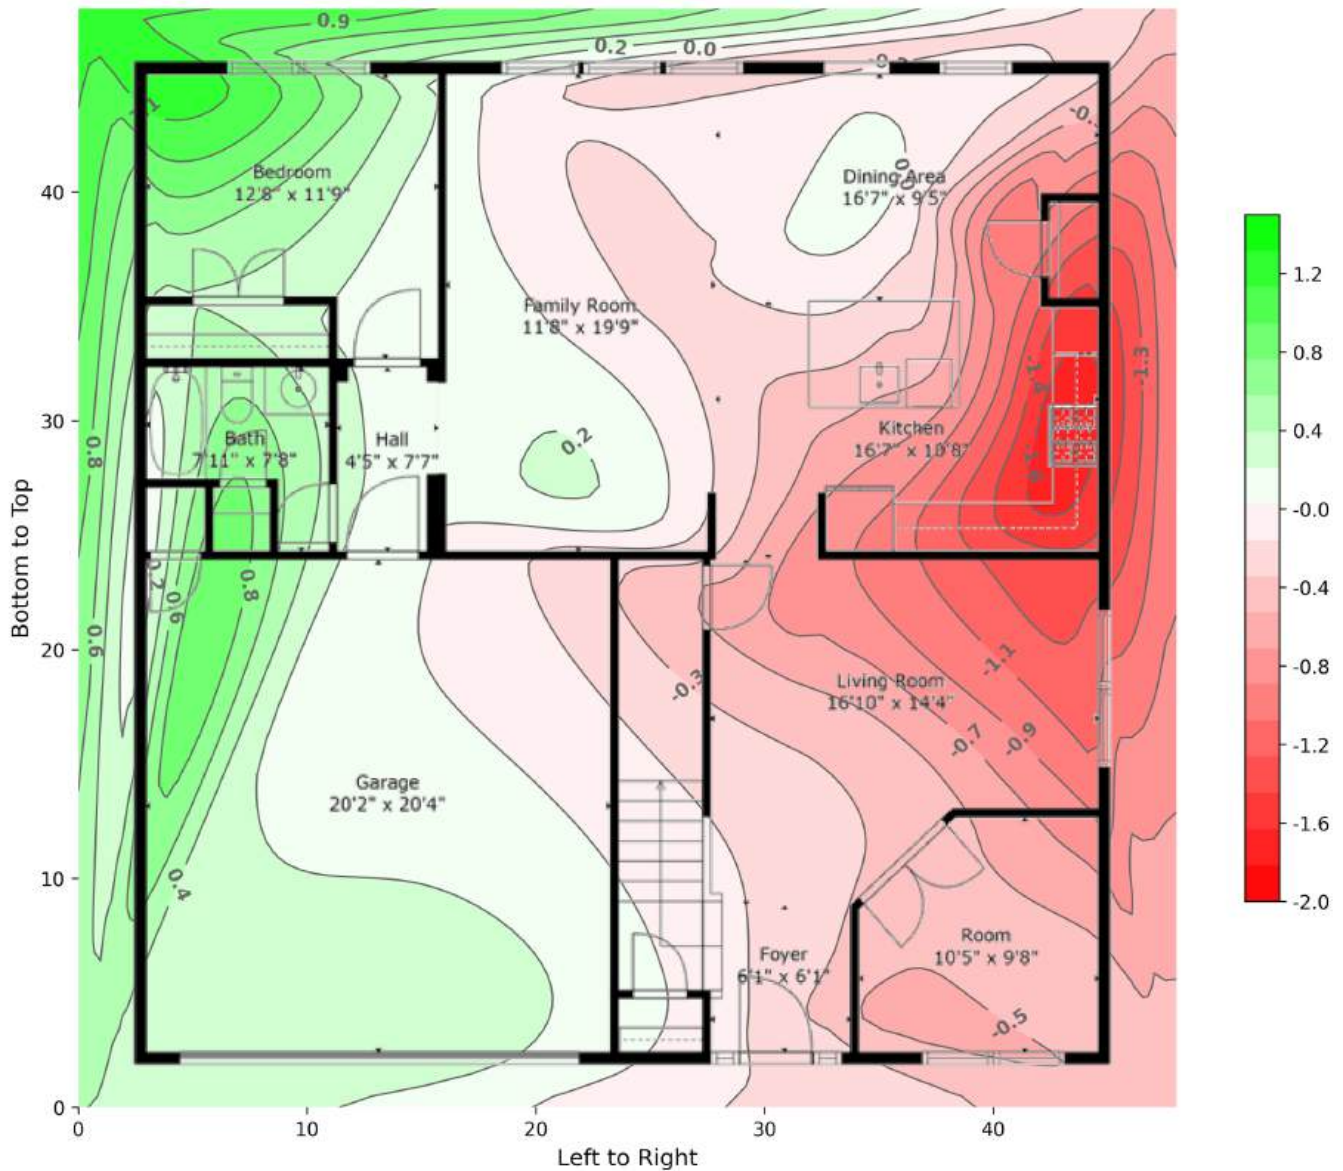
**Mesh Contour Graphic (Figure B)**

The mesh contours graphic depicted above in Figure B is similar to the elevation plot. The red, green, and white areas depict areas that are lower, higher, and equal to the base station elevation (0.0). The contour intervals are labeled.

As documented above, the maximum elevation point of this structure was determined to be 1.2 inches and the minimum was -1.7 inches, resulting in an elevation difference of 2.9 inches of difference across the structure. The elevation deflection across an entire structure should remain within 0.5 to 1-inch depending on the age of the structure. Measured differences approaching 2-inches are a sign of foundation fatigue. The maximum allowable elevation difference is subjective, depending on other factors such as the visual condition and age of the structure (19 year(s) old).

Based on observed elevations of the foundation from the elevation plot, the structure cannot be considered fully stable. Elevation differences do not fall within industry standards or tolerable limits. These findings indicate that the foundation does not have consistent and uniform elevation demonstrating continued movement of the foundation.

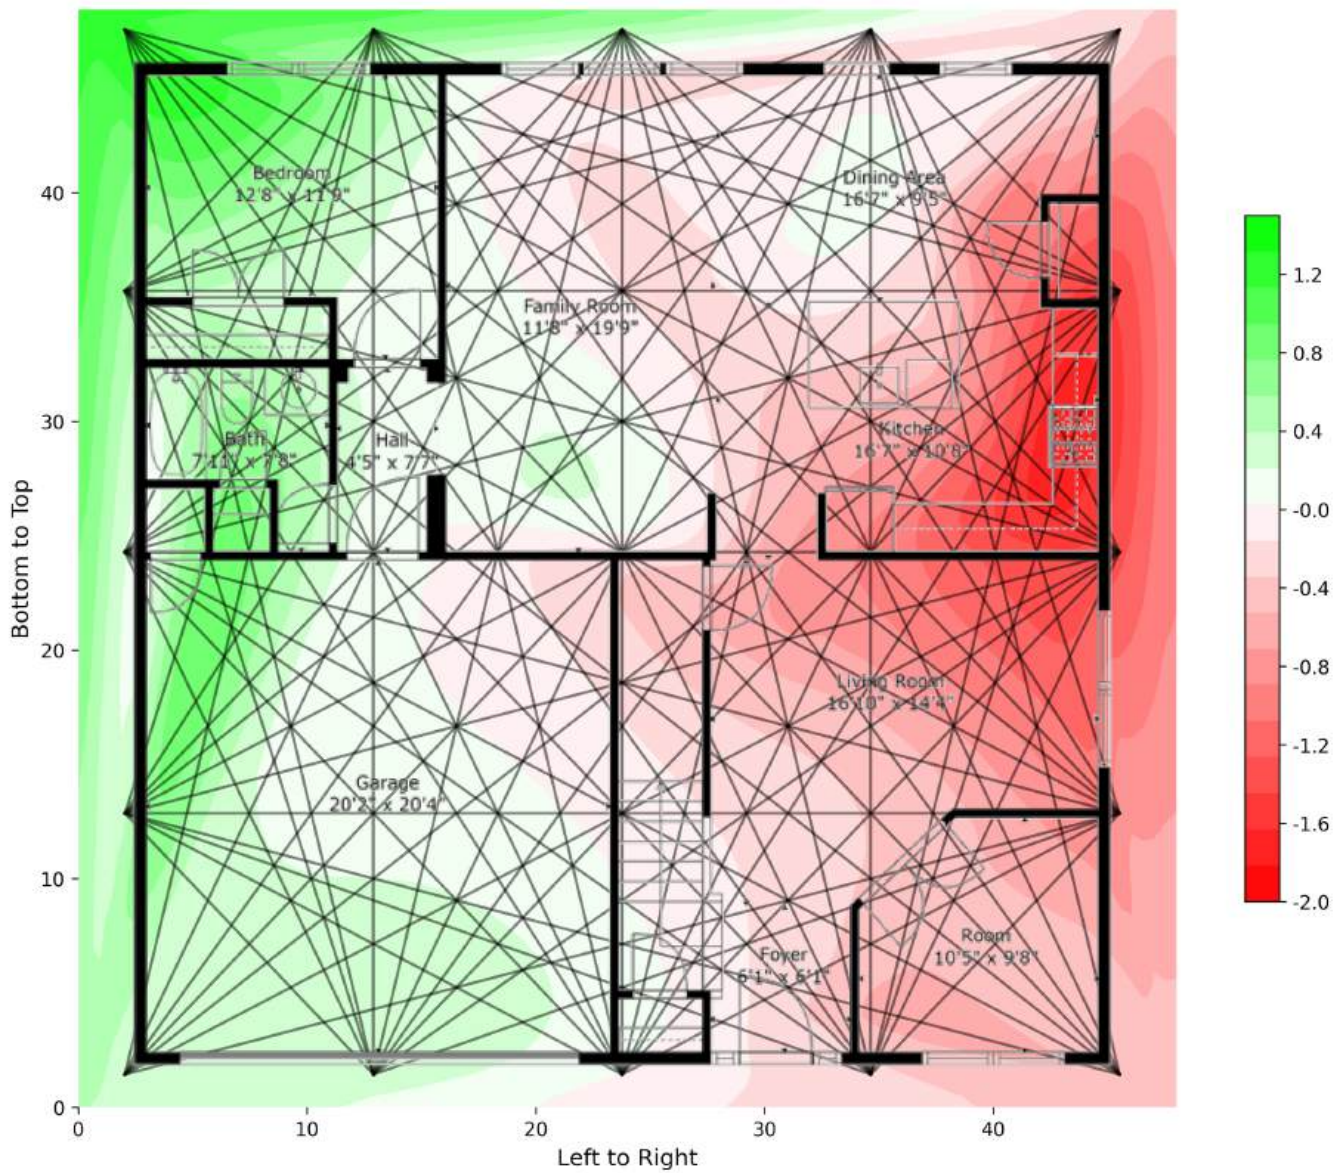
**All Profiles Graphic (Figure C)**

Below is a graphic that shows the locations of deflection and tilt profiles that were calculated. The total profiles calculated was 79 with a total usable profiles (above the effective length threshold) of 76.

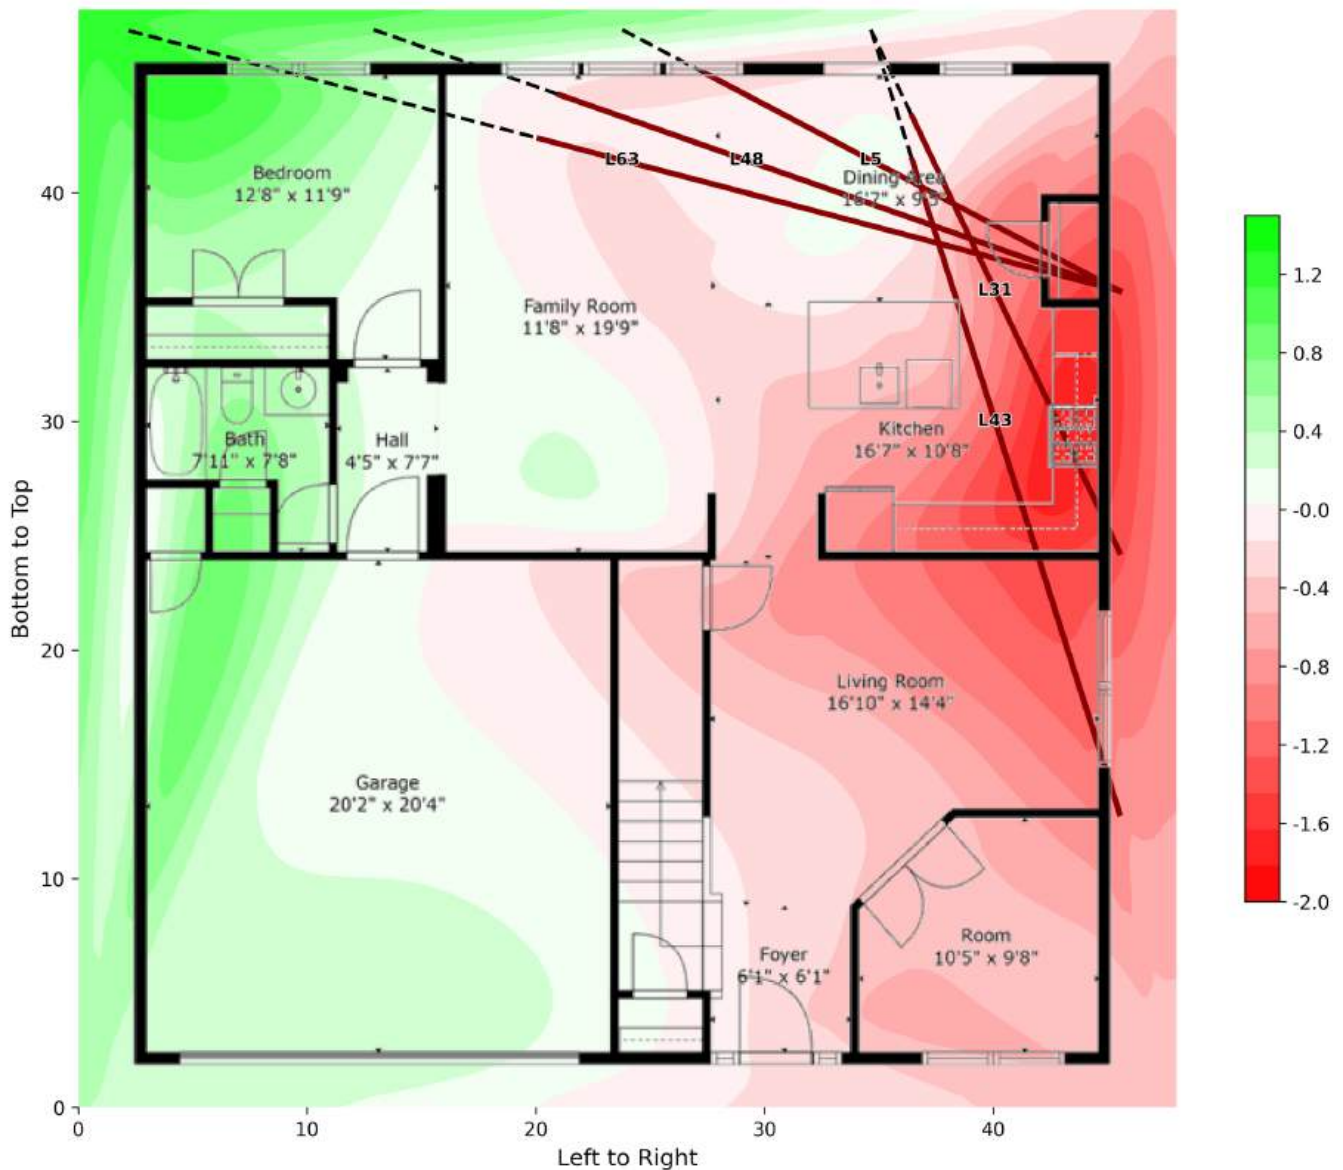
**Deflection Failures Graphic (Figure D)**

The above Figure D shows deflection failures along the foundation. Deflection failures can be considered localized failures in (sometimes) isolated portions of the foundation. The profile lines that were calculated are represented by a dashed black line and the areas that the deflection failures occur are represented by a dark red line segment. Of the 76 deflection profiles calculated, 5 profile failures were identified.

Deflection failures can be considered localized failures of the foundation in (sometimes) isolated portions of the foundation. Of the 76 deflection profiles calculated, 5 failures were identified.

Deflection failures are above standard acceptable limits; they exceed industry-standard thresholds and the structure should be considered actively moving/settling in areas where deflection failures are occurring.

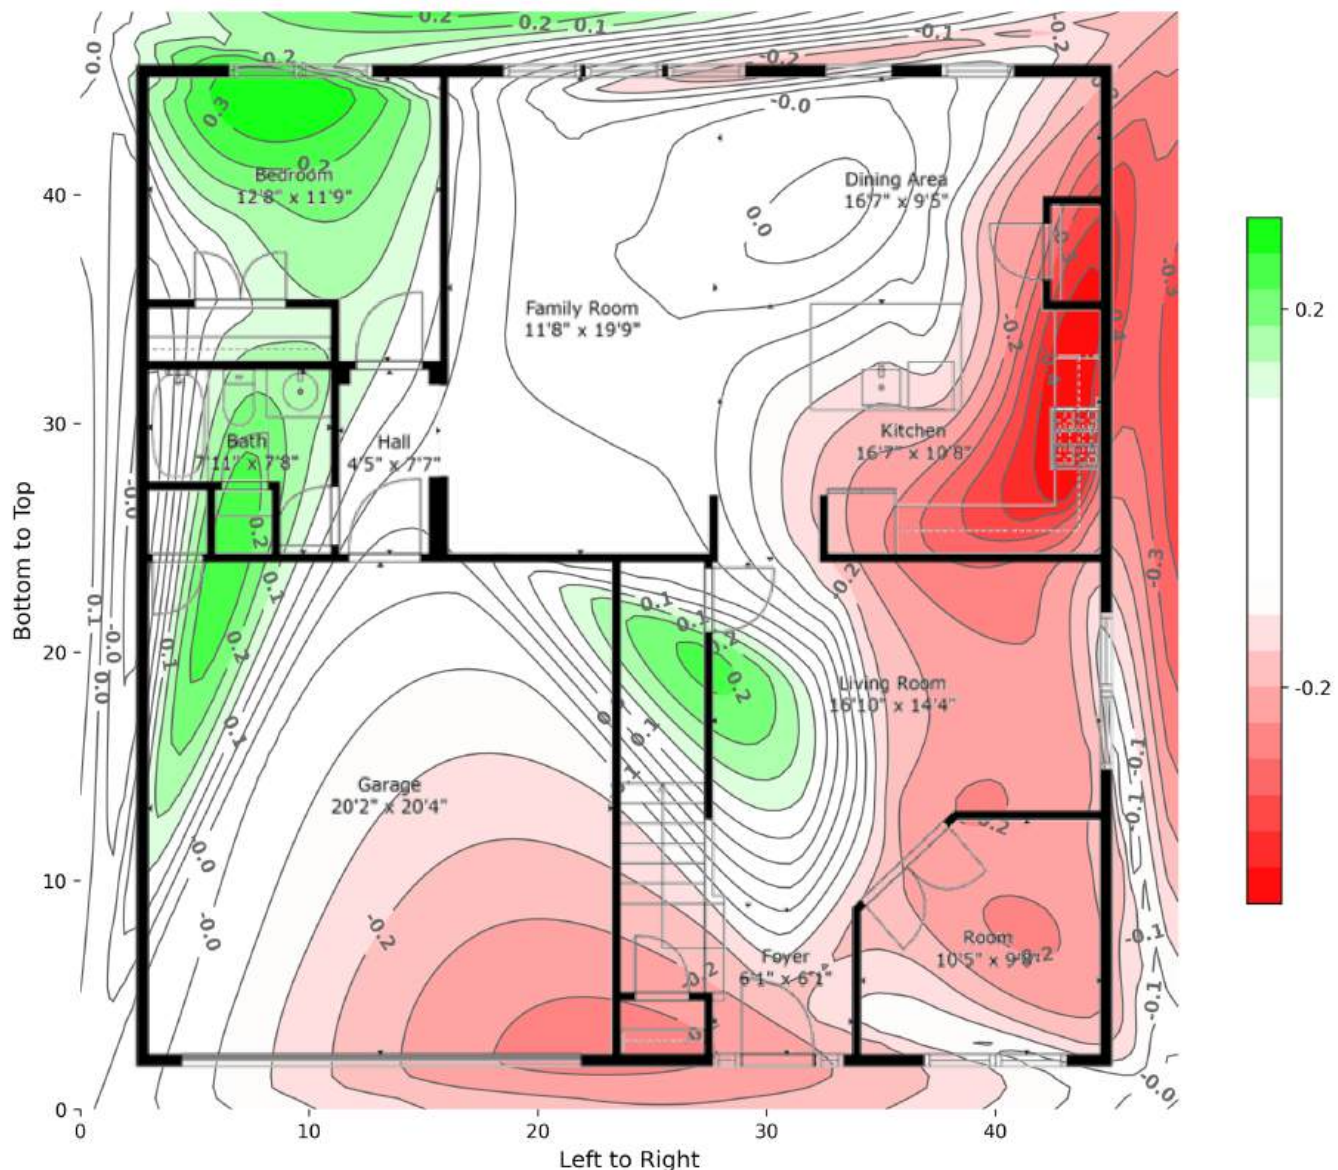
**Elevation Plot Difference Graphic (Figure F)**

The mesh contour graphic above in Figure F shows areas in red that are lower than the baseline elevation plot and areas of green that are higher than the baseline elevation plot (from the provided drawing completed in 1998). The darker the color (both red and green) the larger/smaller the elevation differences.

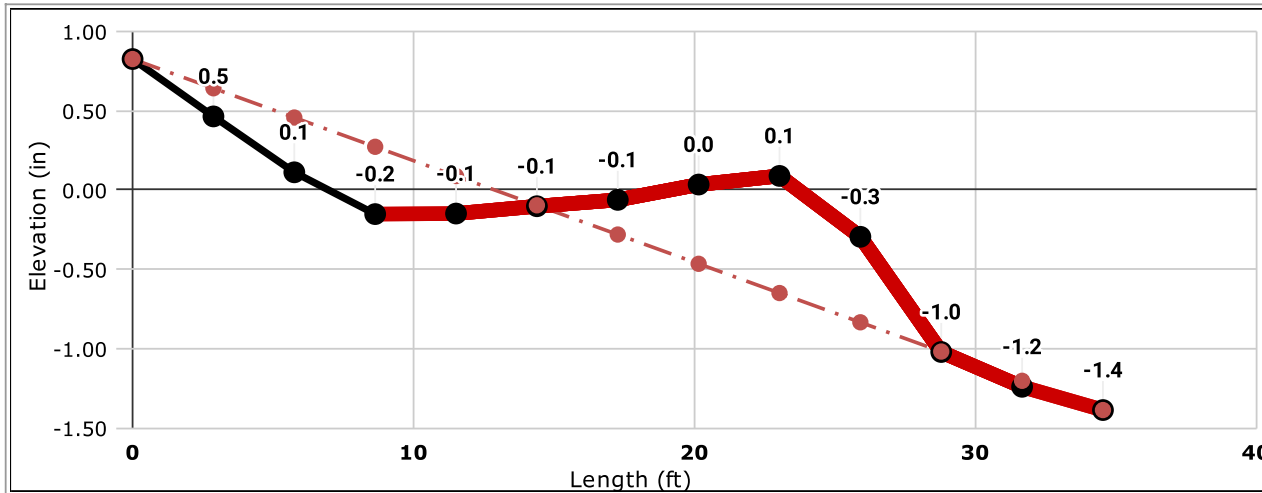
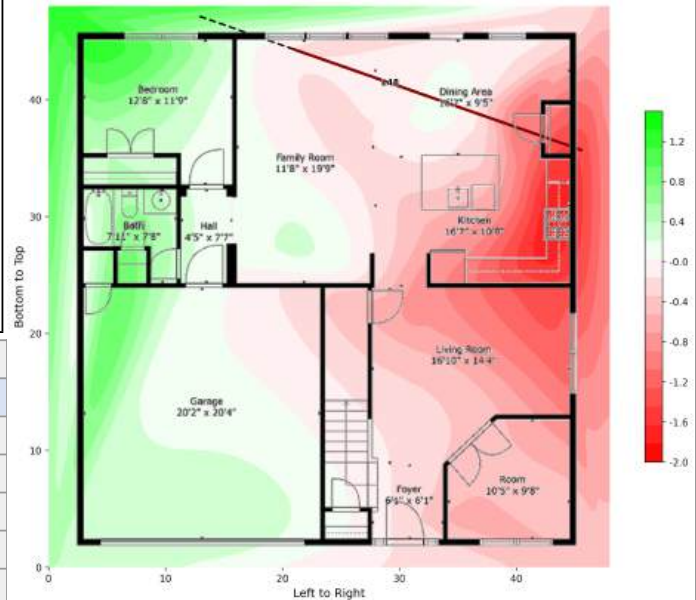
## Exhibit A: Identified Deflection/Tilt Failure (L48)

Performance Output							Point 1	Point 2	Point 3
Deflection & Tilt	Pass/Fail	Actual		Result Description					
Deflection 1 (using k)	FAIL	L /	281	EXCEEDS THE kL/360 (L/340) LIMIT BY 21%			4	9	11
Deflection 2 (using k)	FAIL	L /	281	EXCEEDS THE kL/360 (L/340) LIMIT BY 21%			5	9	12
Deflection 3 (using k)	FAIL	L /	300	EXCEEDS THE kL/360 (L/340) LIMIT BY 13%			4	9	12
Deflection 4 (using k)	FAIL	L /	323	EXCEEDS THE kL/360 (L/340) LIMIT BY 5%			5	9	13
Deflection 5 (using k)	FAIL	L /	326	EXCEEDS THE kL/360 (L/340) LIMIT BY 4%			6	9	13
Tilt	PASS	0.53	%	USING 53% OF THE ALLOWABLE 1% LIMIT
