# Executive Summary

# Engineer's Foundation Evaluation

123 Sample Address, Your City, CO, 12345

On 4/1/2024 a foundation evaluation was performed at the property located at address 123 Sample Address, Your City, CO, 12345, which consists of a 2042 square-foot single family attached structure built in 2005 with a block / pier & beam foundation.

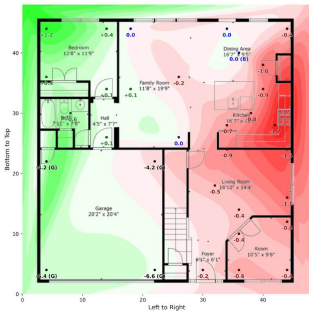
Figure A

This evaluation indicates clear signs of foundation issues. Calculations were not found to be within industry standard limits. Remedial measures are required to bring the foundation to a more level condition. It is recommended that foundation stabilization be completed as soon as possible, if possible within the next year. In addition, visual deficiencies noted should be resolved after foundation improvements have been completed. We also recommend you perform another house elevation plot after repairs have been completed to memorialize the elevation changes. Due to the nature that foundation work is recommended, it is imperative that you read the entire report in detail for a comprehensive explanation of this conclusion.
